Assessment of Recent Aircraft Lightning Accidents

Dave Walen
FAA Aircraft Certification Service
Chief Scientific and Technical Advisor -
Lightning and Electromagnetic Interference
(425) 227-1156 dave.walen@faa.gov

Presentation Topics

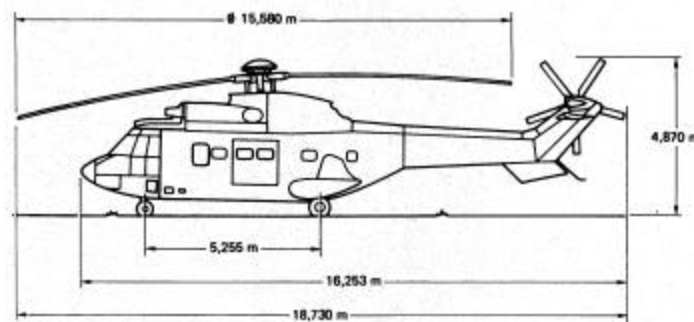
Aerospatiale AS-332L

- Lightning attached to tail rotor blades and main rotor blades
- Significant damage occurred on one tail rotor blade
- Blade imbalance caused bolts holding tail rotor gearbox to fail
- Tail rotor gearbox separated from helicopter

- Damage to tail rotor blade caused unbalance and vibration
- Bolts holding the tail rotor gearbox to tail boom failed, so gearbox separated from the helicopter
- Analysis and test showed that loss of titanium leading edge could cause vibration to failure

- Original AS-332 lightning protection was not tested to today's standard
 - Original lightning protection was qualified to much lower action integral
- Tests using today's standard caused tail rotor blade damage that could result in loss of titanium leading edge
- AD was adopted to require lightning protection improvements

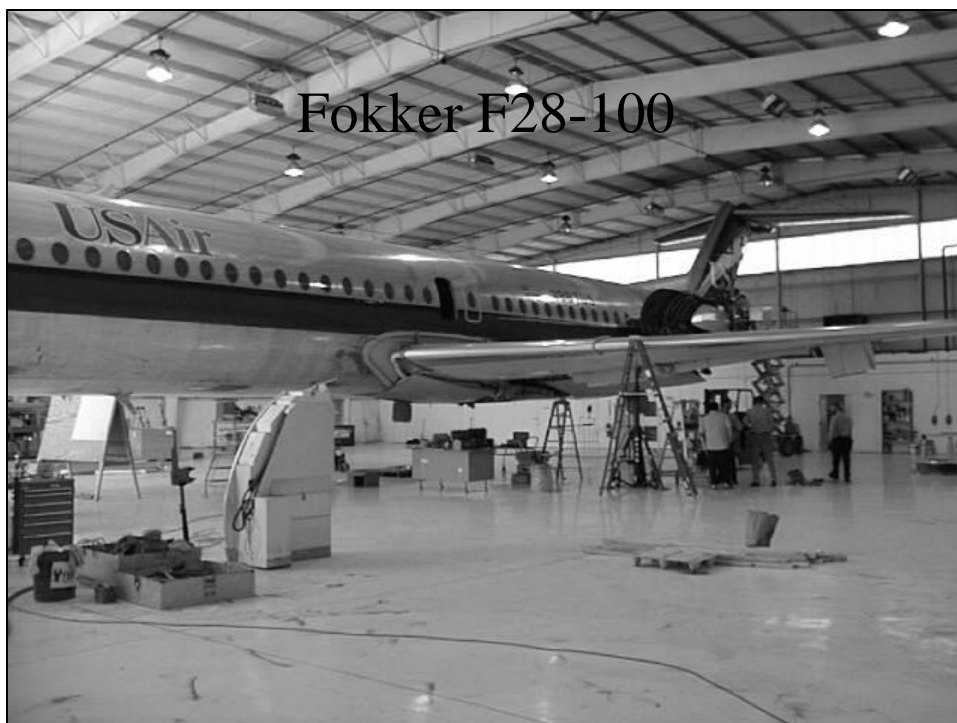
Fokker F28-100

- Lightning attached along lower right side of fuselage and right horizontal stabilizer tip
- Arcing to hydraulic tubes in the horizontal stabilizer hinge area burned holes in two tubes - one from each system
- Loss of both hydraulic systems, and an unrelated brake antiskid failure caused loss of directional control on landing

- Single small-gauge bonding strap carried significant lightning current
- Lightning current fused the bonding strap and arced to adjacent hydraulic tube
- Current on hydraulic tube then arced to adjacent hydraulic tube for second hydraulic system

- Bonding strap was not sized to carry high lightning currents
- Stabilizer hinge and jackscrew cannot be relied on for lightning current path
- Lightning protection must consider the conducted current paths, not just the lightning attachment locations

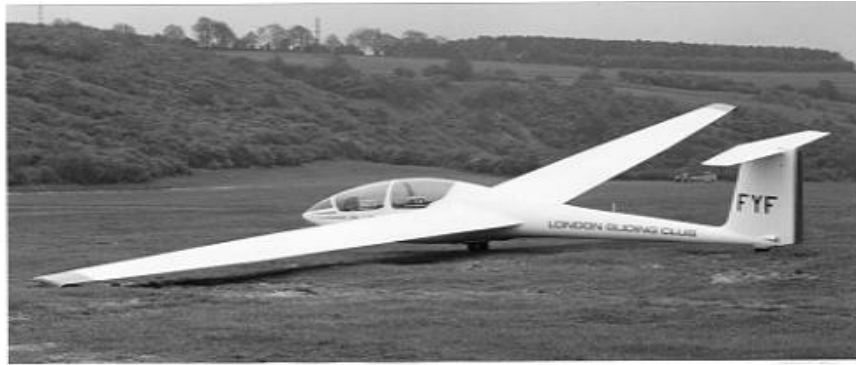
Figure 1

ASK 21 Two Seat Glider

Manufactured in Germany by A Schleicher. Wing span 17m Max AUW = 1320 lbs

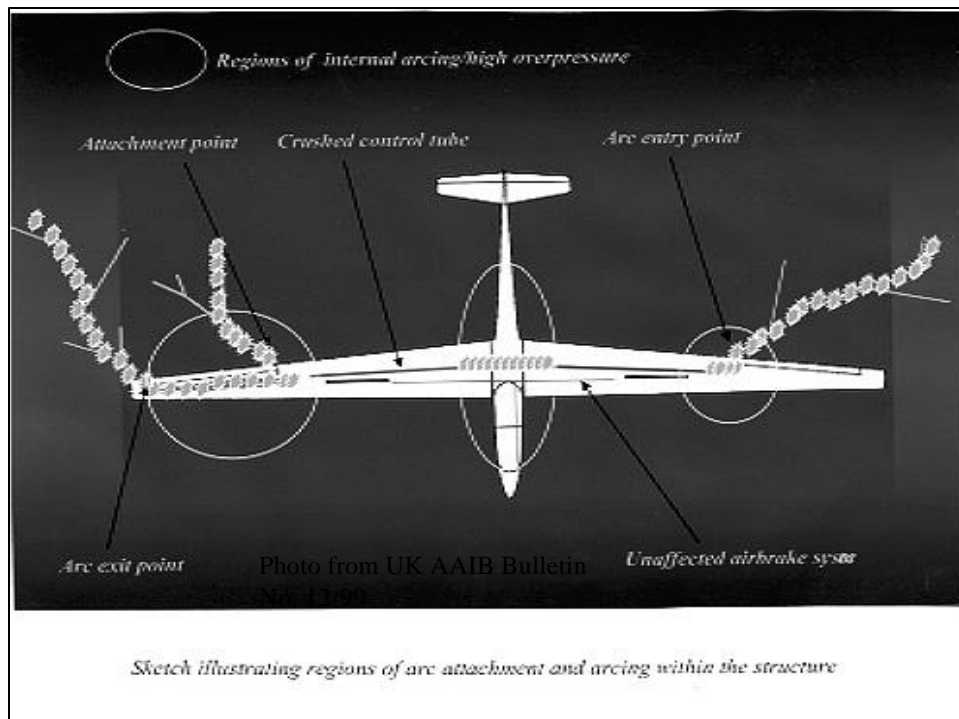
- Lightning attached to both wings
- Explosive arcing in wing and fuselage caused structural failure of wing and fuselage
- Significant lightning arc welding on control rod brackets
- Significant magnetic deformation of control rod tubes

- Schleicher ASK-21 has no inherent or designed lightning protection
- In general, gliders are not required to have lightning protection
- Lightweight fiberglass and foam structure is not tolerant of explosive arcs within the structure
